Beyond the Painted Surface: Conserving the Yeh Chi Wei Paintings in the National Heritage Board Collection

By Mar Gomez Lobon, Conservator (Paintings)

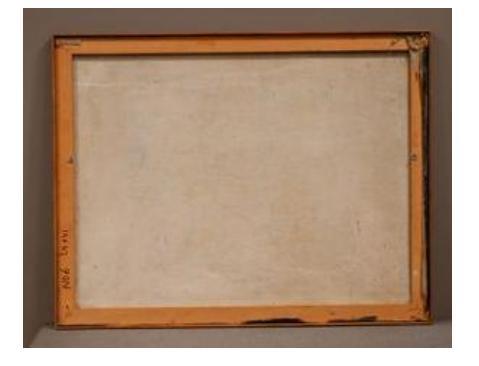
Many of Yeh Chi Wei's paintings have signs of re-stretching after the creation of the work. This is evident in cases where there are two or more sets of tack or staple holes, or where the paint layer is folded over the side of the stretcher, such as in *Singapore Seafront* (Fig. 1). Others present parallel horizontal or vertical cracks, such as in *Angkor Wat* (Fig. 2), which often appear when a painting has been rolled. It is likely that paintings were unstretched and rolled for storage for long periods of time, and re-stretched only when works had to be displayed. In fact, many of the paintings kept with the Yeh family are still unstretched.

Fig. 1: Back of Singapore Seafront showing paint folded over the edge. Fig. 2: Vertical cracks in Angkor Wat viewed with raking light.

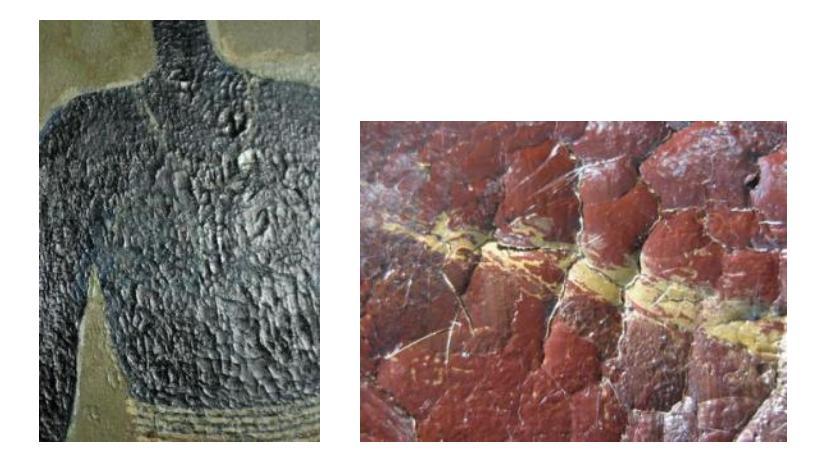
In some cases, this rich application of paint in successive layers has resulted in extensive cracking in certain colours. Cracks and separation of paint layers can appear very early in an oil painting when 'lean' paint (mixed with turpentine) is applied on top of 'fat' paint (straight out of the tube or mixed with oil).⁹ Cupping, a form of cracking where the edges of the cracks raise to form small concave islands of paint in the form of a 'cup', was also found in many of his works. The painting *Drummer* presents one of the most pronounced cases of cupping (Figs. 6 & 7). This form of cracks is also a consequence of the technique used by the artist and the application of many consecutive layers of paint. As a consequence of early formation of cracks and pronounced cupping, many paintings have suffered from lifting and flaking of paint, resulting in extensive losses of original paint.¹⁰

Fig. 6 & 7: Details of cupping cracks in Drummer.

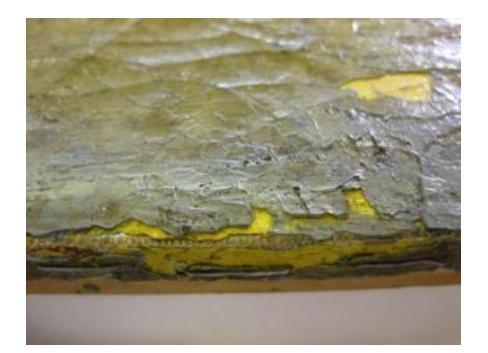
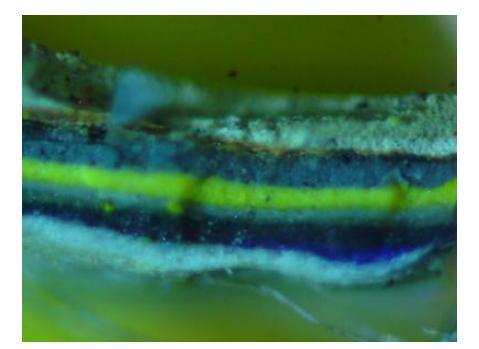
In a few paintings it was observed that the number of paint layers was unusually large. In some of these instances, losses of paint revealed another layer of paint underneath with contrasting or unrelated colours that did not correspond to the artwork, such as in *Portrait of a Dayak Lady* (see Fig. 8). This raised the question of the possible presence of another painting underneath the existing one. In an attempt to confirm this possibility, tiny samples of flaking paint were taken from *Portrait of a Dayak Lady* and cross-sections were prepared.¹¹ When samples were observed under microscope, it was found that as many as nine layers of paint were present in the samples (Fig. 9). A second layer of white priming on top of thick layers of paint was found in all samples examined. In some cases, this white layer is on top of a thin resinous glaze or varnish, which is normally applied as

a final layer of paint. This leads to the conclusion that the artist did paint *Portrait of a Dayak Lady* over another work, after applying a layer of white priming over it. The reason for this remains unknown, but possible explanations could be dissatisfaction with the previous work, or unfavourable circumstances leading to the 'recycling' of paintings materials. Other works that appear to have been painted over another artwork include *Angkor Wat* and possibly *Bust of Angkor*.

Fig. 8: Edge of *Portrait of a Dayak Lady* showing layers of paint underneath. Fig. 9: Cross-section of sample taken from the left edge of *Portrait of a Dayak Lady*.

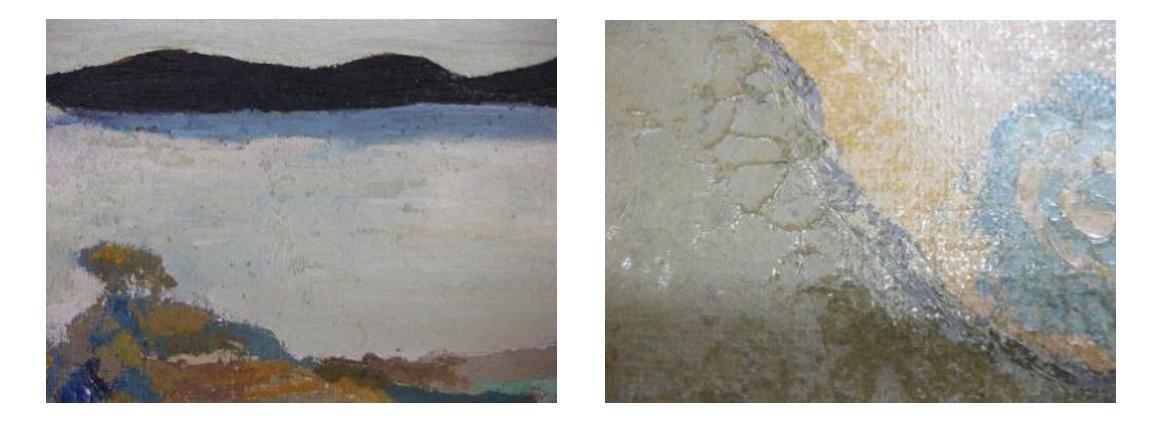
Many of the paintings examined were heavily restored, presenting large areas painted over old losses of original paint. In some cases, such as in *Lake Toba* (see Fig. 10), these overpainted areas are so extensive that it is unlikely that it is the result of a previous restoration. These overpainted areas look like they were done quite soon after the creation of the artwork when observed under Ultraviolet (UV) light.¹² Therefore it can be presumed that the artist himself painted them. It is quite likely that the paintings presented early problems of flaking, resulting in losses of paint, which led to the artist repainting damaged areas of the work.

Fig. 10: Detail of overpainted areas over losses of paint in Lake Toba. Fig. 11: Detail of cracks in Untitled.

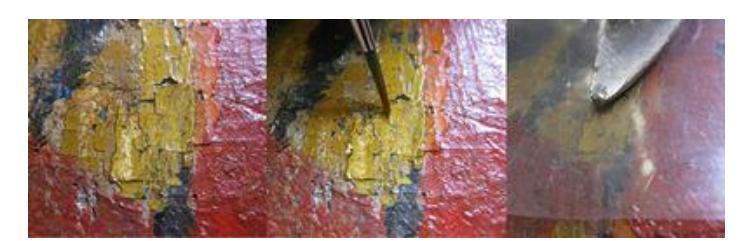
Fig. 15: Consolidation of flaking paint in Portrait of a Dayak Lady.

In preparation for the Yeh Chi Wei exhibition, 21 oil paintings were conserved at the Heritage Conservation Centre laboratories. As mentioned in the previous section, many of the paintings presented conservation problems such as pronounced cracking of the paint surface, flaking and extensive losses of original paint; in many cases, they had been overpainted by the artist at an earlier stage. All flaking paint was secured back into its original position by many hours of consolidation treatment. Consolidation is the process by which an adhesive is applied to restore the adhesion between layers that have separated, e.g., between primer and canvas, or between various layers of paint. The adhesive is applied with a small brush followed by application of heat to help the penetration and sealing of paint layers (Fig. 15). Nearly all of the paintings conserved required some degree of consolidation to secure the flaking paint. Where the losses of paint presented a perceptible discontinuity in the image, these were reintegrated. Reintegration is the process by which the losses of paint in a painting are restored, thus recovering the continuity of the image. This is done by the application of a filling material to level the loss of paint with the surface of the painting followed by the application of colour to match the surrounding original (Figs. 16 & 17).

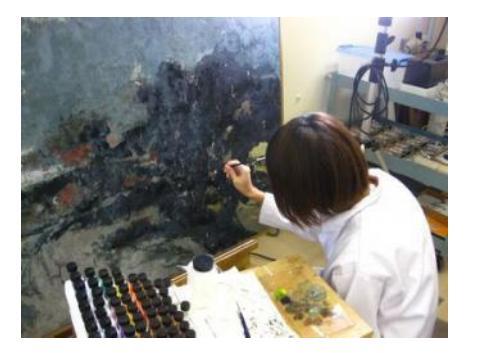
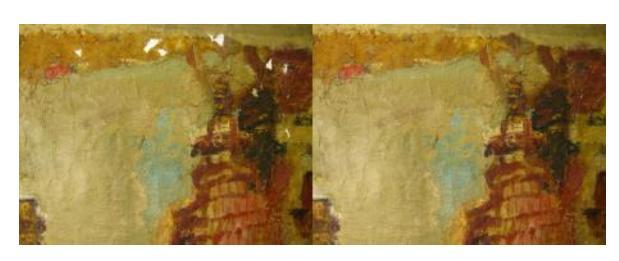
Fig. 16: Inpainting for Mountain View Fig. 17: Detail of Angkor Wat before and after inpainting.

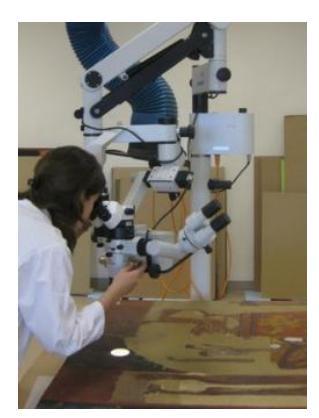
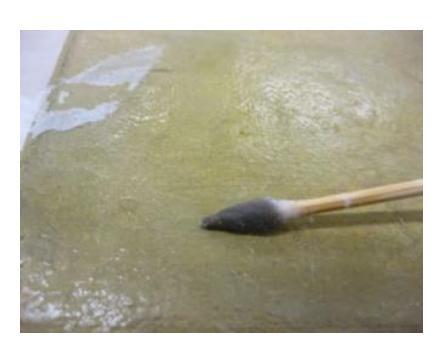
Many of the paintings also had evidence of mould. Mould is a common occurrence in tropical climates such as Singapore's and it is commonly found on paintings that have been kept in humid environments without proper ventilation. Mould must have already been a problem in the early years after the paintings were created, since for some works, mould stains are present under the varnish layer. Examination of affected areas under the microscope can often help determine the degree of mould activity (Fig. 18). A number of paintings also presented discoloured varnishes, and dirt accumulation on both front and back of the painting. Therefore, another common treatment was surface cleaning to remove superficial layers of accumulated dust and mould (Fig. 19).

Fig. 18: Examination of mould stains under microscope in *Untitled (Temple Scene)*. Fig. 19: Surface cleaning of *Untitled*.

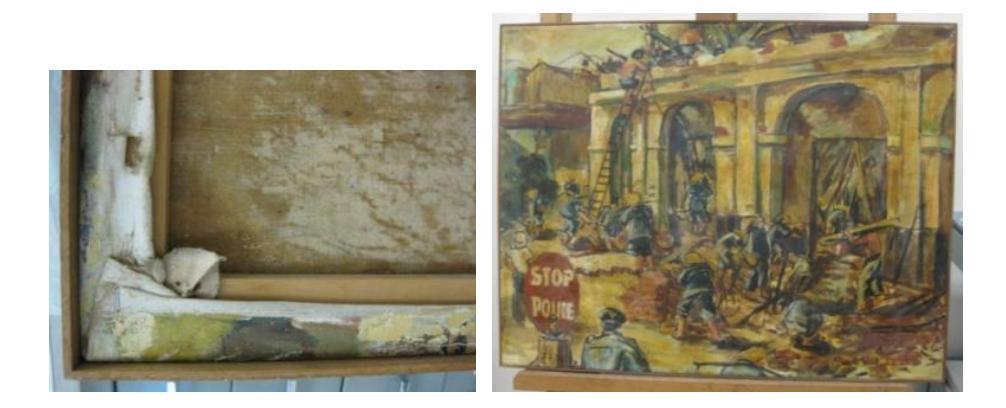
During the initial examination, it was found that the canvas was very loose on its stretcher and had many distortions and creases. In a manner similar to other works, the painting had been restretched onto a smaller strainer (stretcher with fixed corners), folding the sides of the painting over the back of the stretcher. (Fig. 21 shows a detail of the back corner of the work before treatment.) Evidence of previous mounting (old tack holes and staple holes) was also found on the edges of the work. The painting was framed with a simple thin wooden frame, nailed directly to the sides of the painting, in a fashion similar to other works in both NHB and private collections.

The painting surface presented mould spots and a very discoloured varnish which was giving the work a dark orange-brown appearance, obscuring the original colours (Fig. 22). Other types of damage present in the painting included two tears (one already repaired with a coarse patch on the back) and some small holes on the canvas.

Fig. 21: Back corner of Untitled (Police Barricade). Fig. 22: Untitled (Police Barricade) before treatment.

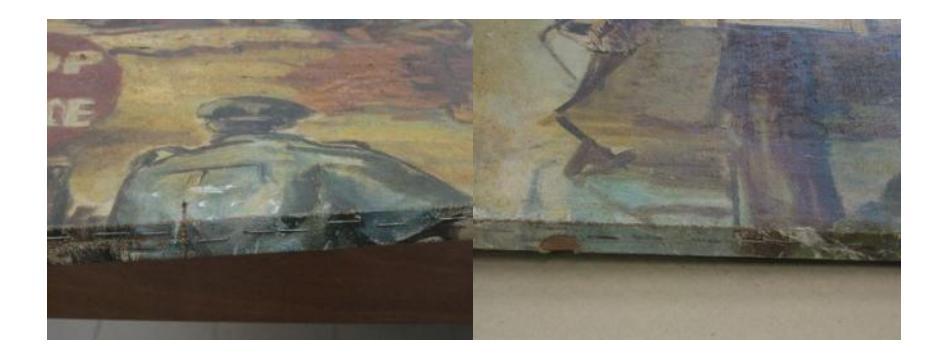
It is quite likely that the artist restretched the painting himself, since the painting remained with the Yeh family until it was donated to NHB. The artist probably folded the edges of the painting in order to cover the tear in the bottom side of the work and one hole on the upper left edge of the painting (Figs. 23 & 24). Its thin wooden frame, nailed directly to the sides of the painting, was probably applied at the same time.

Fig. 23 & 24: Detail of edges of Untitled (Police Barricade) after removing the frame.

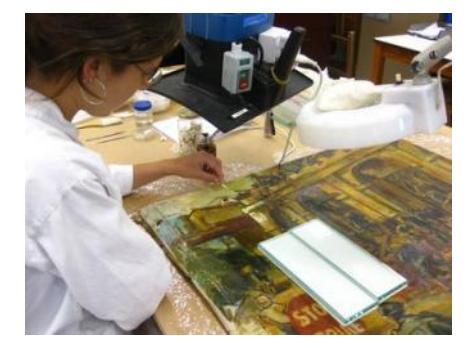
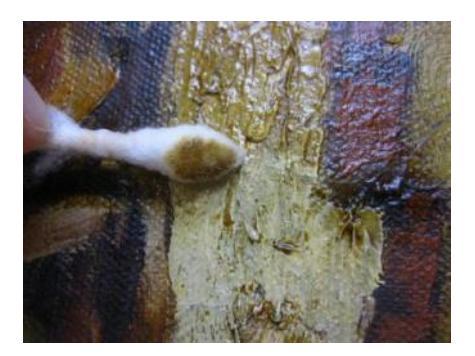
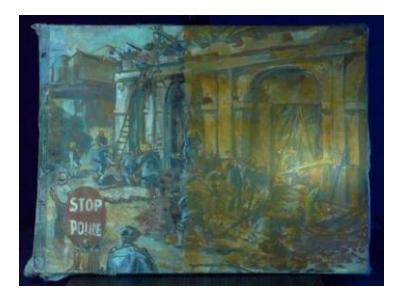
The varnish was identified as shellac by its characteristic fluorescence under UV light (refer to Fig. 28). Shellac is not recommended for use as a varnish for paintings, as it oxidises quite quickly over time, resulting in a very orange-coloured coating. Therefore, a decision was made to remove the varnish based on the following reasons:

Fig. 26: Removing oxidised varnish from Untitled (Police Barricade). Fig. 27: Detail of discoloured varnish being removed from the white colour.

Fig. 28: Untitled (Police Barricade) with varnish removed from its left half when viewed under UV light. Remaining shellac varnish has a characteristic orange fluorescence under UV light.

Tests were carried out to determine the solubility of the varnish and to test an adequate solvent that would not affect the original paint. Varnish was then removed by softening it with solvents applied with cotton swabs over the whole surface of the artwork to allow for the swelling of the oxidised varnish (Figs. 26-28). The removal of the varnish returned the painting to its original vibrant colours.

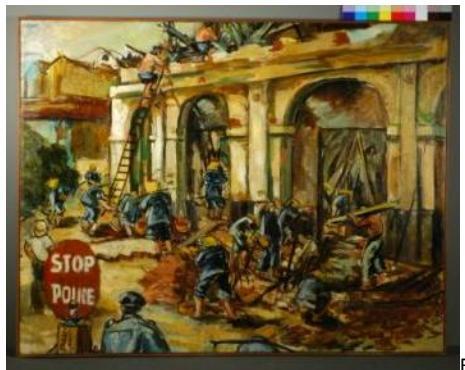
Fig. 29: Untitled (Police Barricade) after conservation treatment.

The painting was therefore mounted back onto its original strainer, with an application of a strip-lining to reinforce damaged canvas edges.¹⁶

A clear coating of acrylic resin varnish was applied to replace the original varnish, and losses of paint were filled and in-painted with pigments and a water-based medium to allow for easy reversibility in the future.

Finally, the original frame was nailed to the sides of the painting using the same holes for the original nails and the back of the painting was covered with a protective backing board.

After conservation treatment (Fig. 29), the painting *Untitled (Police Barricade*) recovered its original bright colours and the continuity of its canvas support. The conservation treatment allowed for documentation of covered parts of the work, while retaining the original mounting and framing style characteristic of many other works by Yeh Chi Wei.
