Beyond the Painted Surface: Conserving the Yeh Chi Wei Paintings in the National Heritage Board Collection

By Mar Gomez Lobon, Conservator (Paintings)

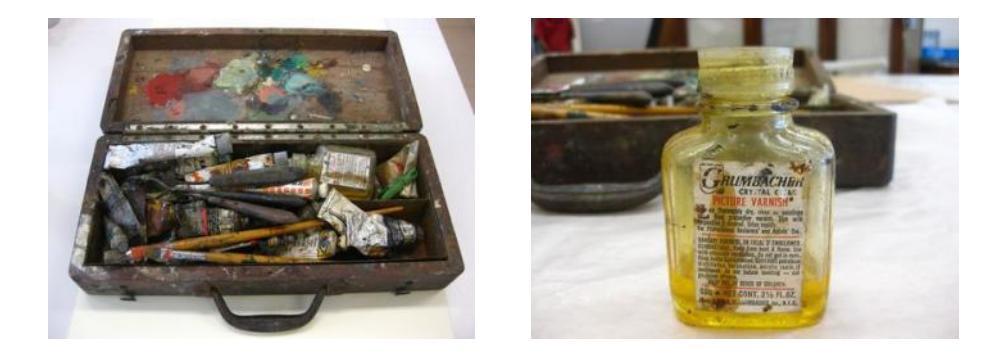
A bottle of the now discontinued painting medium 'Win Gel' was also found in his paint box. This viscous medium, made of a synthetic resin,⁵ was used as a medium to increase the gloss and transparency of colours. According to information provided by Winsor & Newton, in some cases Win Gel was "a little difficult to break down and to mix smoothly with colours" and it has now been replaced by Liquin Light Gel.⁶

Another interesting finding was an old bottle of yellowed Grumbacher 'Crystal Clear Picture Varnish,' made of synthetic resin according to its label (Fig. 5). From its name 'crystal clear,' it can be presumed that this varnish was originally transparent, and its current yellow colour is the effect of aging. At the time of writing, it is unknown if Yeh Chi Wei used this particular varnish to coat all of his paintings; however, many of his works in the collection present varnishes that have also yellowed over time.⁷

Fig. 4: Yeh Chi Wei's paint box. Collection of the Yeh family. Fig. 5: Varnish bottle found in Yeh Chi Wei's paint box. Collection of the Yeh family.

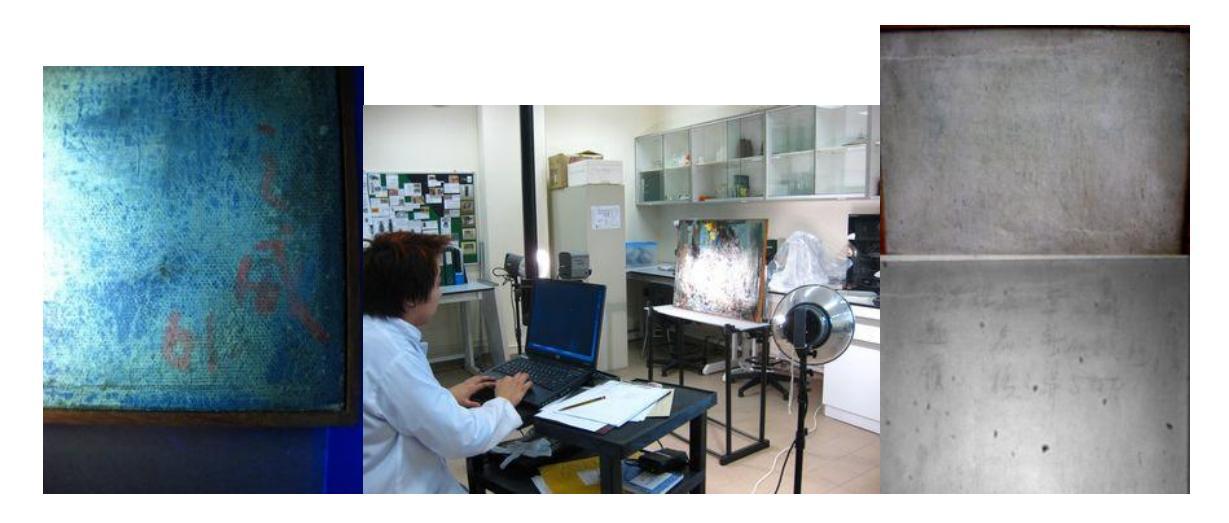
In the painting *Singapore Seafront*, the bottom and right edges of the work are folded over the stretcher (refer to Fig. 1). This raised doubts about the position of the signature, which was in a 'normal' position (on the bottom right corner), but if the edges of the painting were to be unfolded then the signature would be placed in an awkward location. The uncertainty was solved by observing the signature under UV light: The signature was painted over the yellowed varnish, confirming that it was applied much later after the completion of the work (Fig. 12). As this is one of Yeh's early works, it is possible that later in life the artist mounted this unstretched painting onto a stretcher by folding the edges (probably to cover some existing damages), framed it and then signed it on the corner. The same type of stretching and framing was observed in many others of his works, both in NHB and private collections. This was most likely done in an attempt to make this group of paintings more suitable for display, maybe on the occasion of an exhibition.

Fig. 12: Signature of Singapore Seafront viewed under ultraviolet (UV) light.

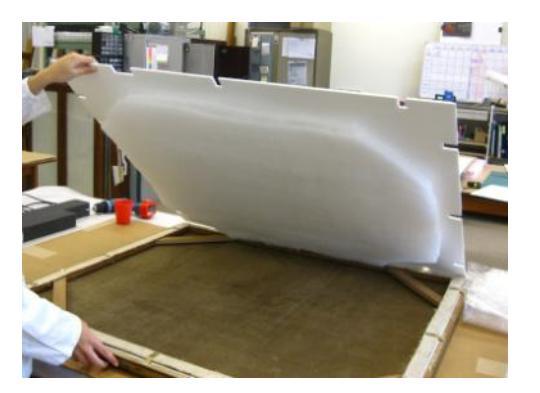
Fig 20: Backing board with polyester wadding insert for Untitled.

Other forms of deterioration included some structural damages such as canvas distortions and deformations. Many paintings had lost their original tension and were therefore slack on the stretcher. In most cases, a preventive approach was taken in order to preserve the original mounting and paintings were left on their original stretcher and frame. A backing board with a polyester wadding insert was applied to the back of the painting to prevent vibration of the canvas when painting is moved or transported (Fig. 20).

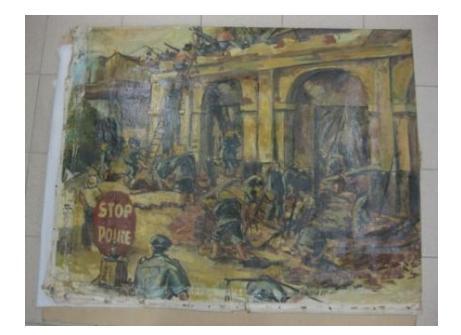
During the initial examination, it was found that the canvas was very loose on its stretcher and had many distortions and creases. In a manner similar to other works, the painting had been restretched onto a smaller strainer (stretcher with fixed corners), folding the sides of the painting over the back of the stretcher. (Fig. 21 shows a detail of the back corner of the work before treatment.) Evidence of previous mounting (old tack holes and staple holes) was also found on the edges of the work. The painting was framed with a simple thin wooden frame, nailed directly to the sides of the painting, in a fashion similar to other works in both NHB and private collections.

The painting surface presented mould spots and a very discoloured varnish which was giving the work a dark orange-brown appearance, obscuring the original colours (Fig. 22). Other types of damage present in the painting included two tears (one already repaired with a coarse patch on the back) and some small holes on the canvas.

As the frame was covering part of the folded image (4.5 cm and 3.5 cm of original paint were folded and covered at the bottom and left sides of the work), we decided to carefully remove the frame from the canvas in order to see if there was any concealed signature. Although no signature was found, the removal of the frame uncovered the previously unseen edges of the work, which contained quite a substantial part of the image.

Once the frame was removed, it was also found that the edges of the work were not varnished, and therefore the yellowed varnish was not original to the work, and had been applied after the restretching. Varnish remains were also present on the sides of the frame, meaning that the work was varnished when it was already in its frame. This varnish could have been applied by the artist himself or at a later date by his son.¹⁵

Fig. 25: Untitled (Police Barricade) after unstretching.

Following unframing, the previously covered edges were documented and the canvas was unstretched. This was necessary in order to access the back of the painting to repair tears on canvas edges. Unstretching allowed the full extent of the image to be seen (Fig. 25),

The canvas was then surface-cleaned, and the old patch and remains of glue were removed mechanically. After that, the distortions on the canvas were flattened and all tears and other damages on canvas were repaired.
